**WHALLEY CREEK  
FISH HABITAT ASSESSMENT**

**1994**

**M.C. Wright and Associates**

**January 1995**

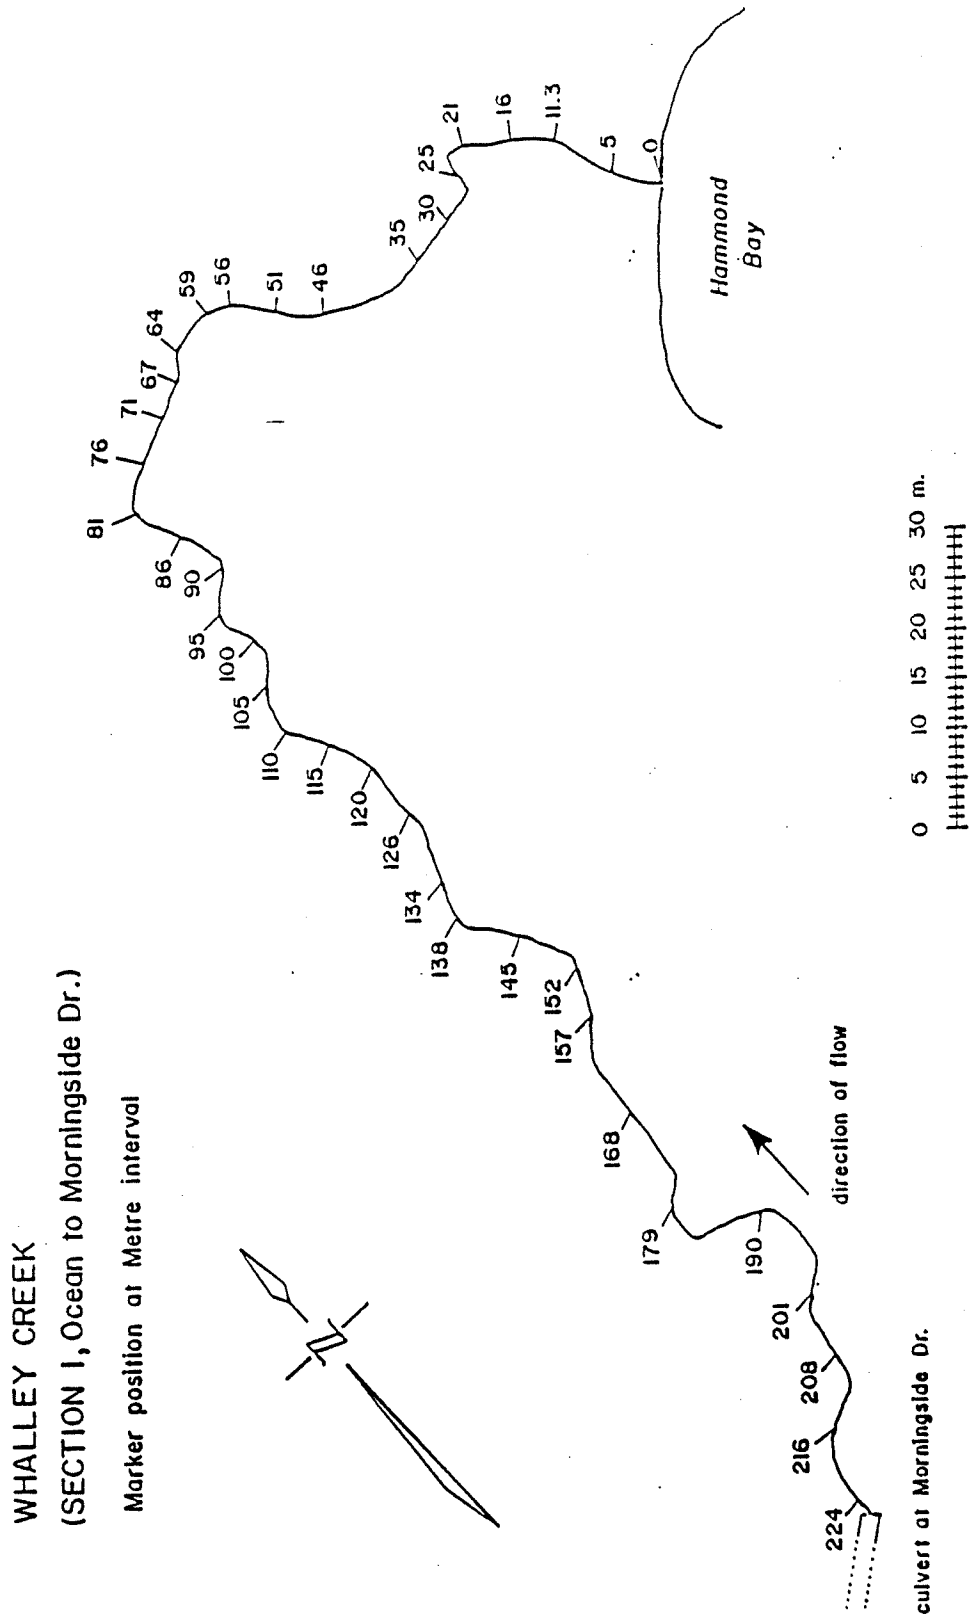
Figure 1. Map of the Study Area, Section 1 (Ocean to Morningside Drive), 1994.

This section flows north paralleling Morningside Drive and then east into Hammond Bay (Fig. 1). The mean gradient of section 1 is 3.9% (range: 0.5% - 13.0%). The stream channel lies within a ravine which rises to a maximum height of 6.8 meters above the stream bottom. Average channel width and wetted width for the 38 transects was 3.67 meters (range: 0.96 - 6.54) and 1.70 meters (range: 0.96 - 3.4) respectively. The mean depth for the wetted area of section 1 is 0.097 meters (range: 0.005 - 0.55).

The area surveyed is characterized by a series of riffles, glides and pools. Riffles and glides comprised 63.87% and 21.73% of the wetted area respectively. Pools comprised 11.4% of the total wetted area. There are a total of 11 pools in this section, which provide fish habitat of varying quality. Pool quality has been defined as average to low for most of the pools in this area because less than 50% of the pool perimeter had fish cover and very little instream cover. Pool cover (such as LOD, organic debris, overhanging vegetation within 0.3 meters of the water surface, rubble, boulders, undercut banks or water depth) (Platts et al. 1983), is defined as any material or condition that provides protection to fish from predators or competitors. Only two pools (M1+11.3 and M1+110) provide good rearing habitat while the rest are considered to be of average to poor quality (Fig.1).

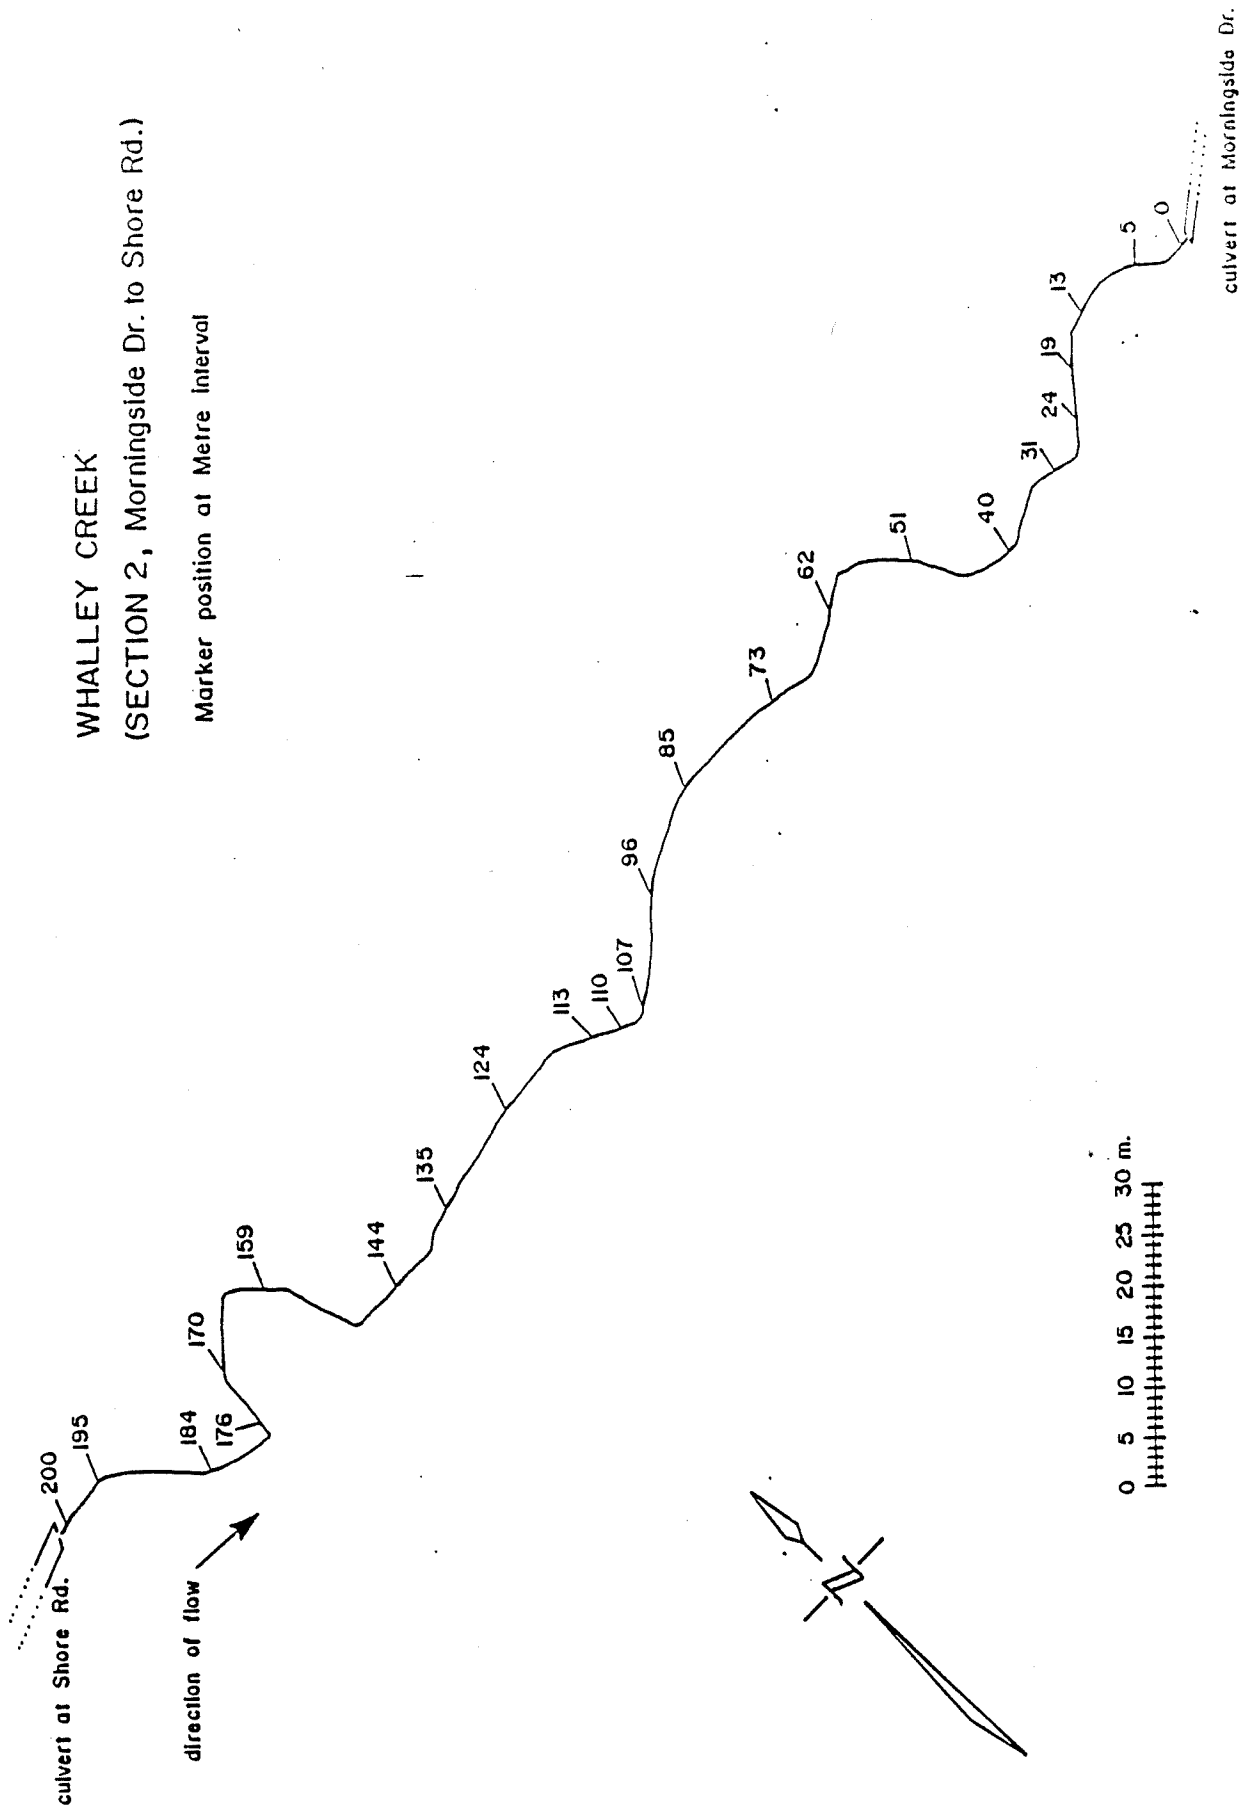
Figure 2 Map of the Study Area Section 2 (Morningside Drive to Shore Road) 1997

This section flows east within a ravine between Shore Road and Morningside Drive (Fig. 2). The maximum elevation of the ravine walls is 5.24 meters above the streambed. The average height of the left and right wall of the ravine is 3.3 meters and 3.86 meters respectively. The measured mean gradient

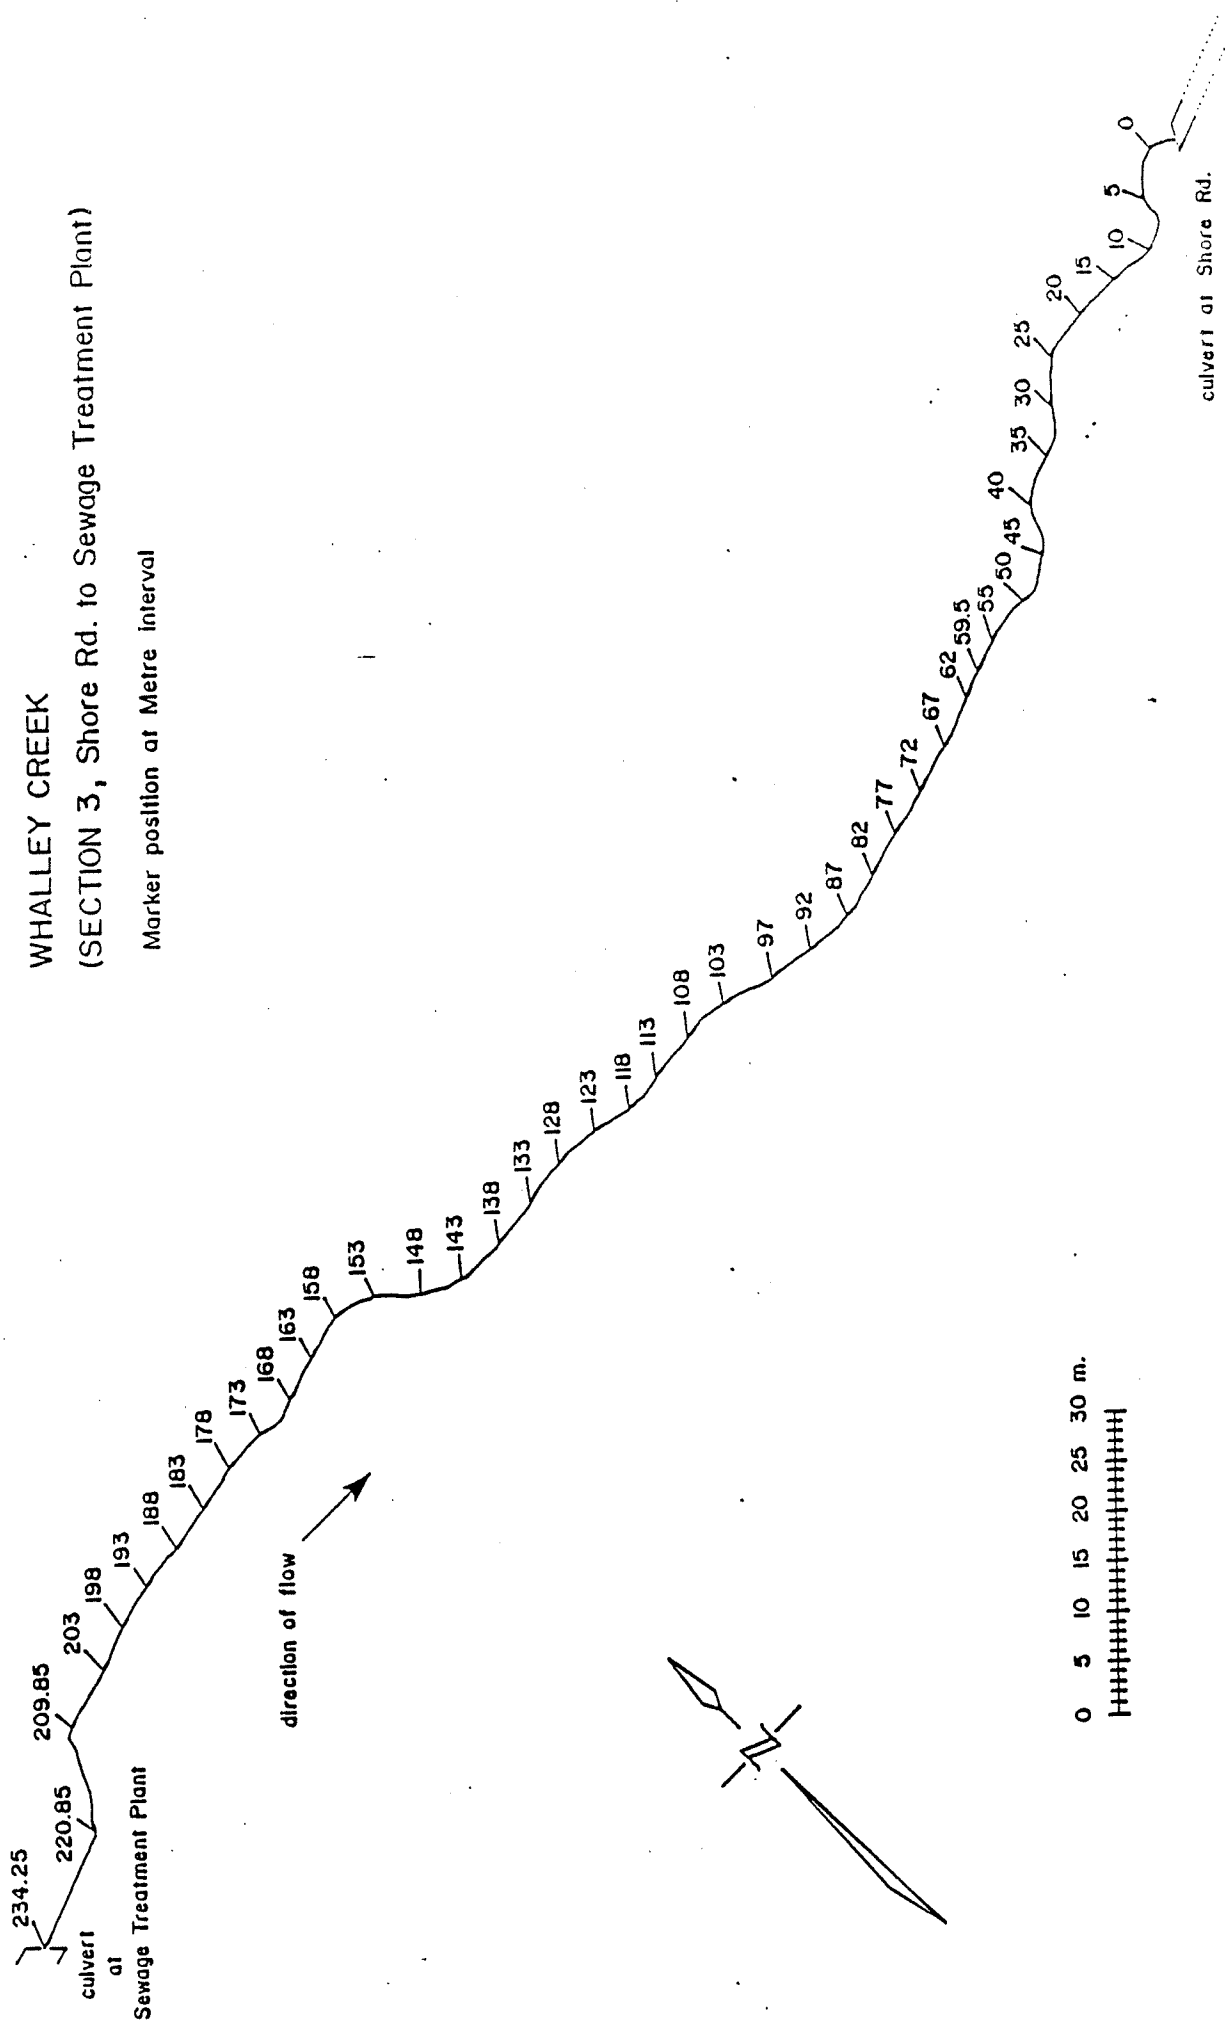
Figure 2 Map of the Study Area Section 3 (Shore Road to Sewage Treatment Plant) 1994

This section flows east between the Sewage Treatment Plant and Shore Road (Fig. 3). Stream habitat was evaluated at 45 transects, spaced primarily (87%) at 5.0 meter intervals (range: 2.5 to 13.4 meters). This area of Whalley Creek is comprised of a series of riffles, glides and pools. Glides are the dominant habitat unit in this section. The three habitat units; glides, riffles and pools comprised 58.02%, 39.25%, and 2.73% of the wetted area respectively.

WHALLEY CREEK  
 (SECTION 3, Shore Rd. to Sewage Treatment Plant)  
 Marker position at Metre Interval
